Iac-MRA Add: F/r 401Building A, Ying Da Feng industrial No,393, Jihua Rd. LongGang Report No: SZ09062021001 Date: 2021/09/06 Email: engineer@iclab-cn.com Page: 1/22

# **Project Inspection Report**

Company	:	<u>NA</u>
Address	:	NA
Sample Name	:	ADXL357BEZ-RL7
Manufacture	:	ADI
Date Code	:	<u>2108,2106,2113</u>
Package Type	:	CLCC14
Sample Number	:	2500 PCS
Check Number	:	<u>122 PCS</u>
Date of Received	:	08/30/2021
Date of Tested	:	<u>10:30/08/31/2021 ~ 17:10/09/02/2021</u>

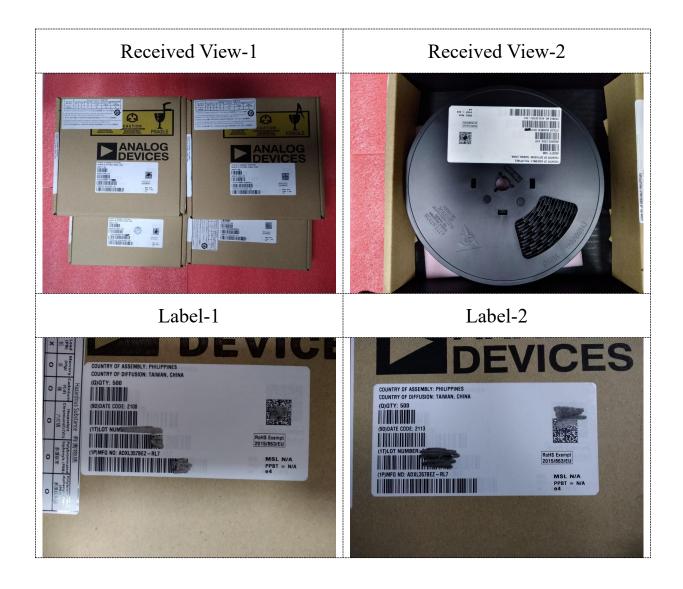
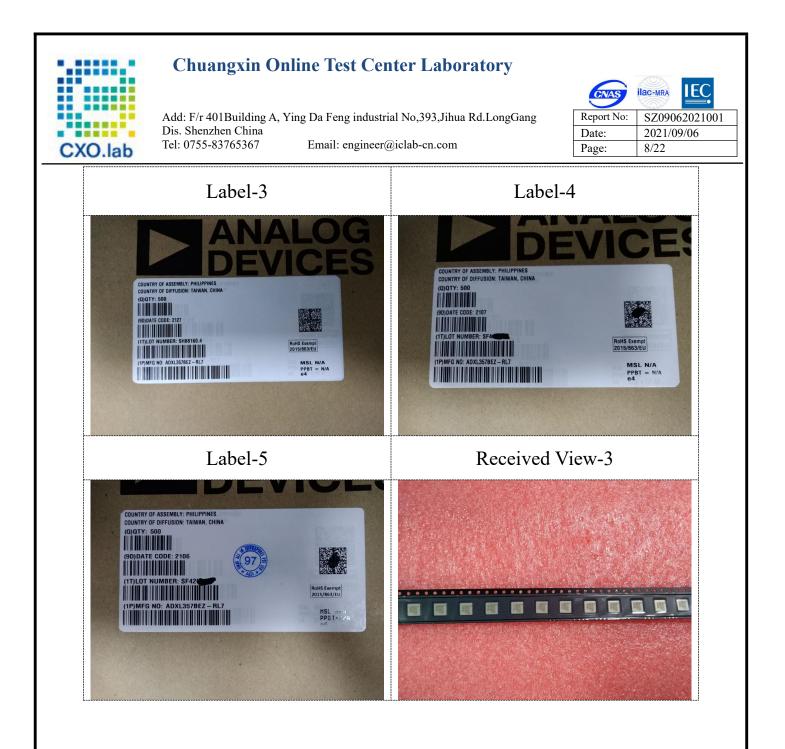
# **3. Receiving Inspection:**

Gross Weight	1036 g	Parts Total	2500 PCS	
Number Of Boxes	4	Full Label	Exist	
Package type	Reel	Moisture protection	Non Present	
MSL	N/A	ESD protection	Non Present

Test samples contain 41 PCS of D/C 2108(B1 to B41) , 41 PCS of D/C 2106(C-1 to C-41) and 40 PCS of D/C 2113(D1 to D40) .

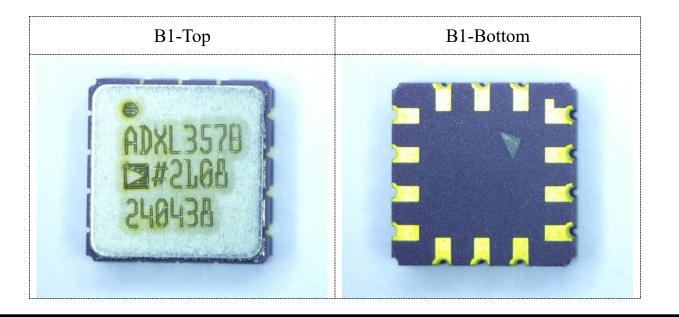
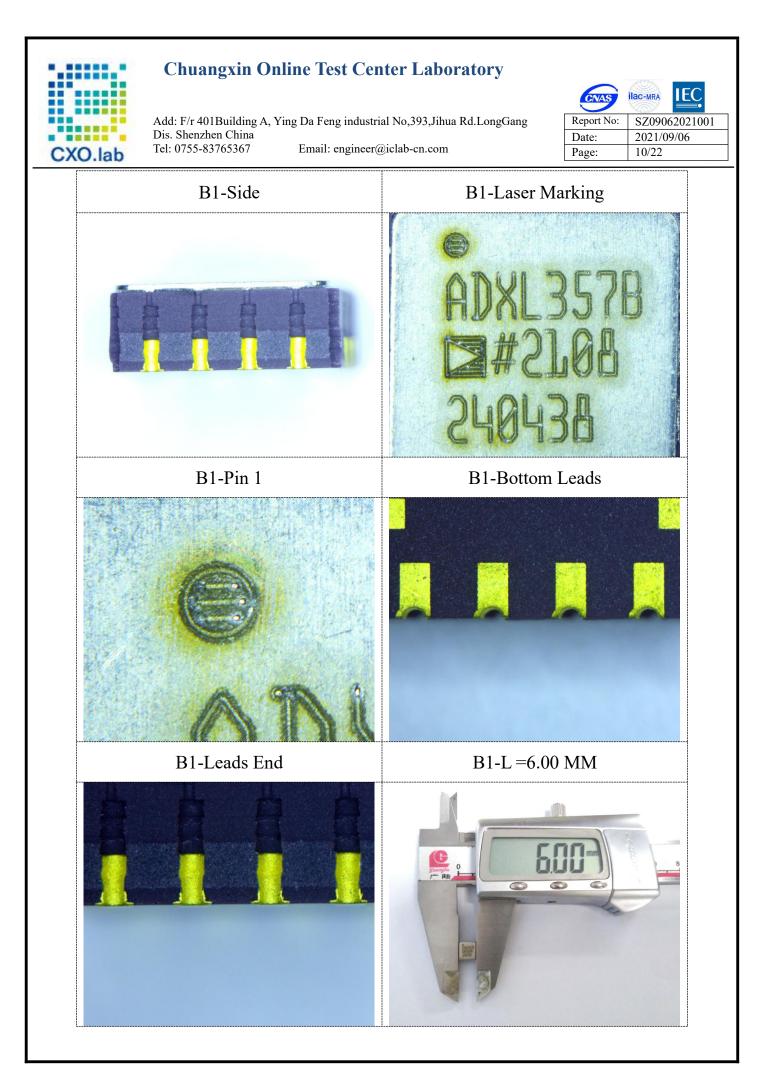
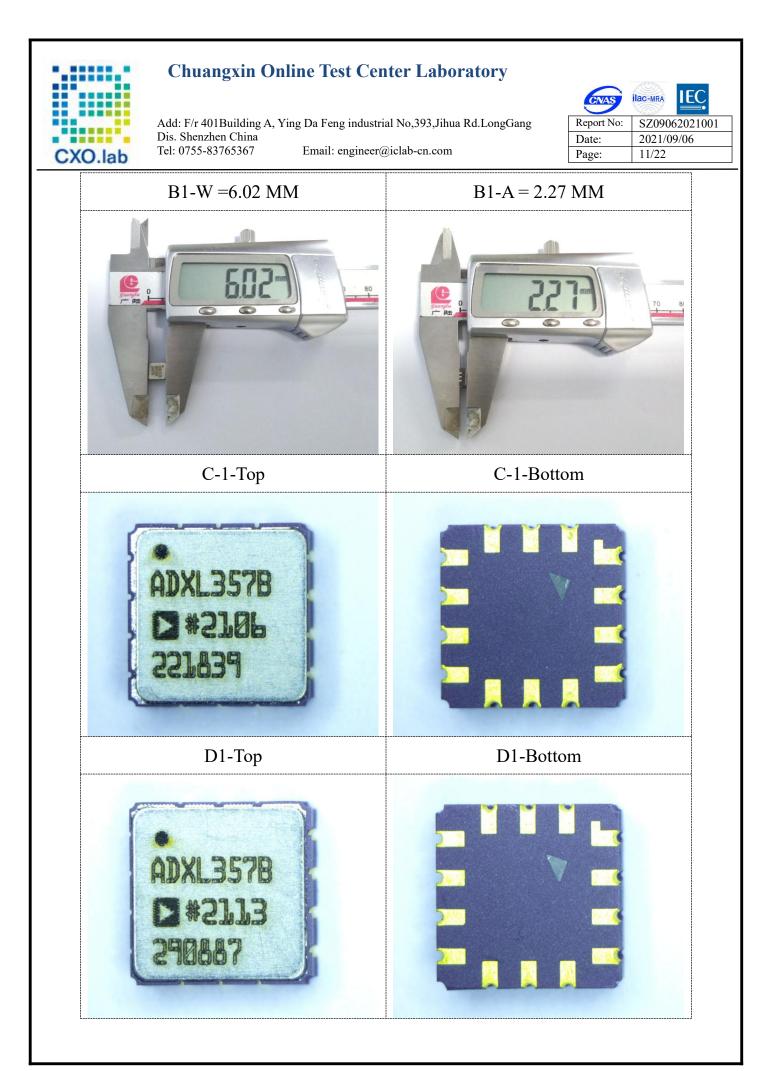
# 4. External Visual Inspection:

External Visual Inspection on 122 PCS(B1 to B41,C-1 to C-41,D1 to D40) samples. No secondary coating, sanding marks, crack or chips were observed on all inspected. Leads were in acceptable condition. Devices package and dimension matched to manufacturer's specification. All devices passed the external visual inspection.

Specification dimension: L: 5.85-6.25 MM W: 5.85-6.25 MM H: 2.20 REF MM Measurement dimension: L: 6.00 MM W: 6.02 MM H: 2.27 MM

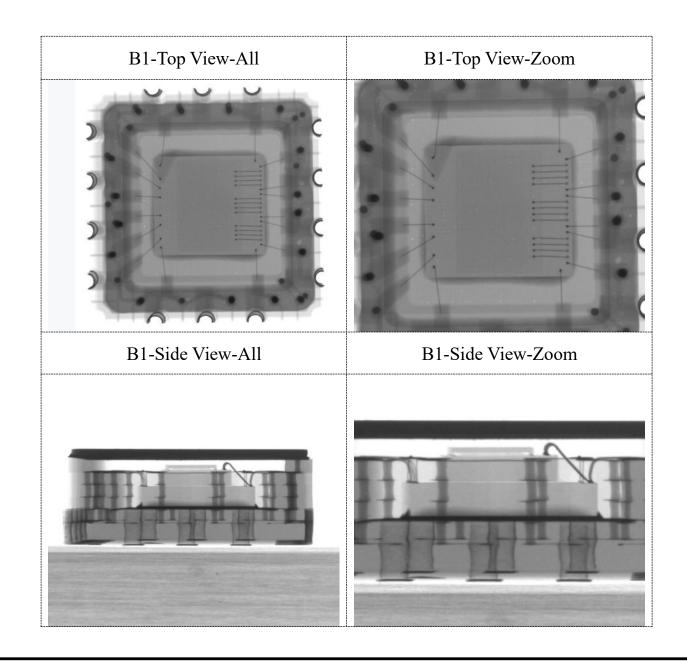
# 5.X-ray Analysis:

X-ray Inspection 49 PCS(B1 to B16,C-1 to C-16,D1toD17)samples . No structure or bonding wire abnormal was found.

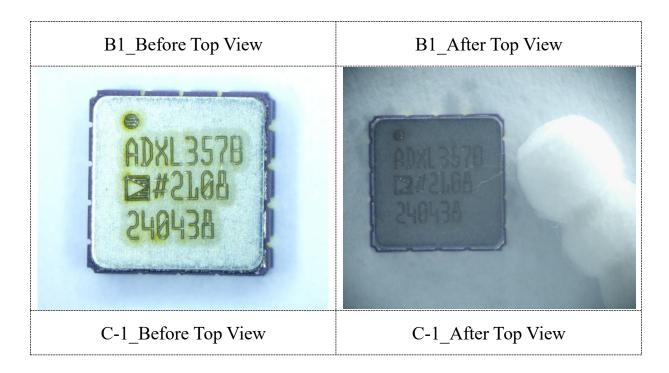
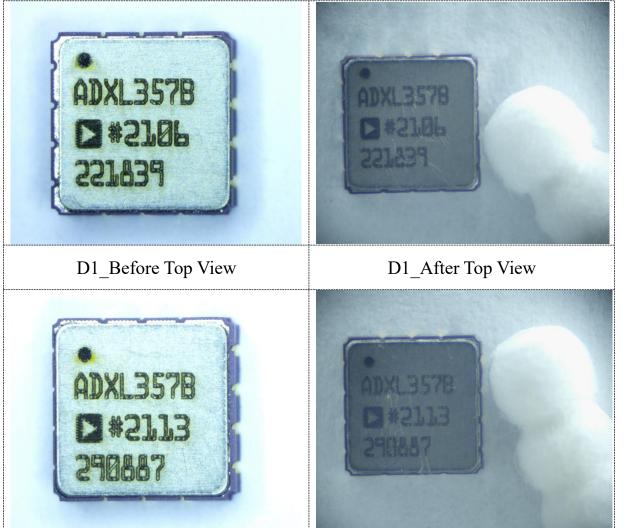
### 7.Heated Chemical Test:

Heated Chemical Test were verified 3PCS (B1, C-1, D1) samples, all samples passed Heated Chemical Test.

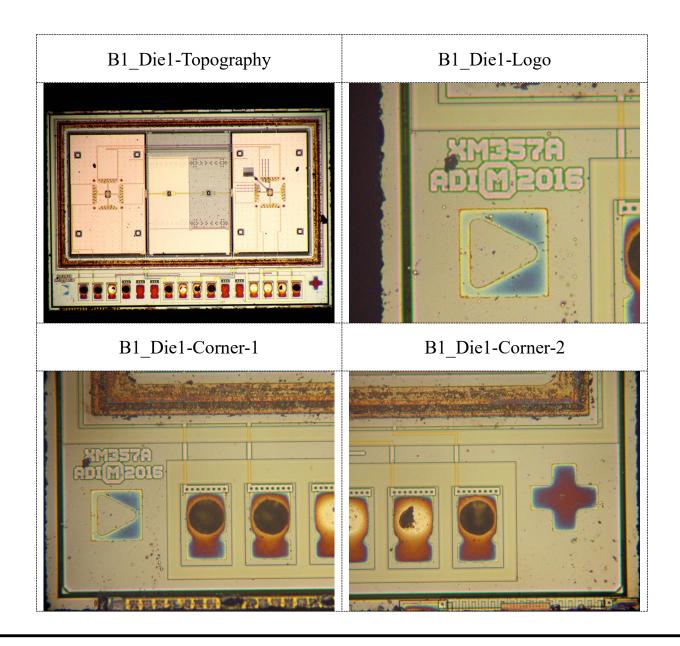
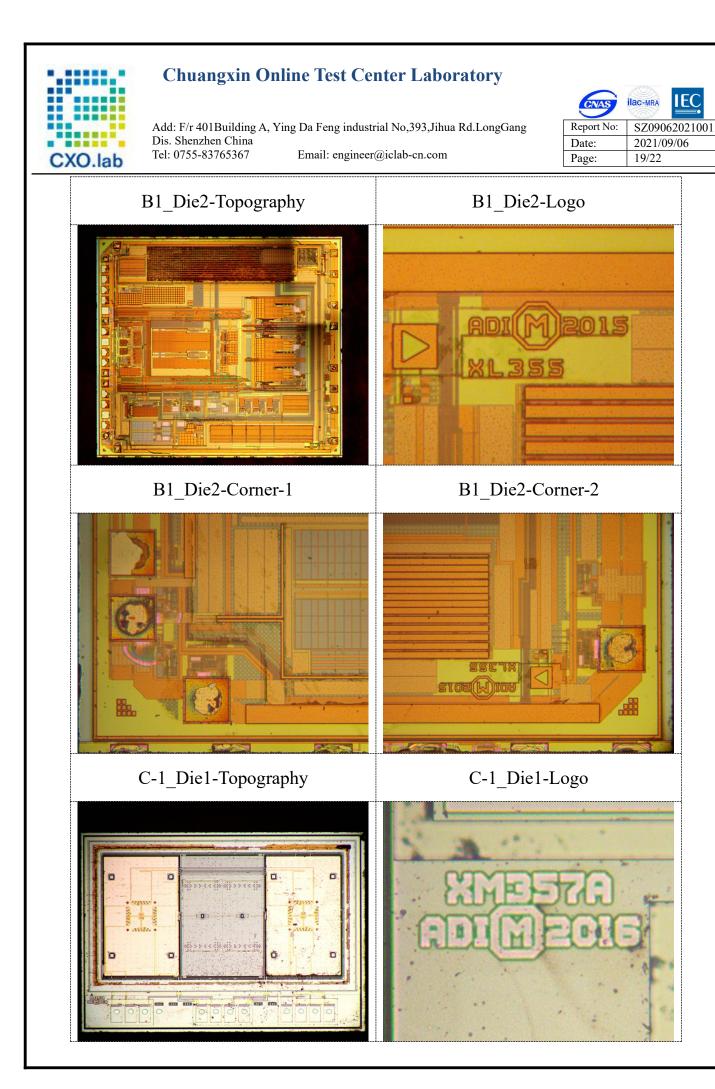
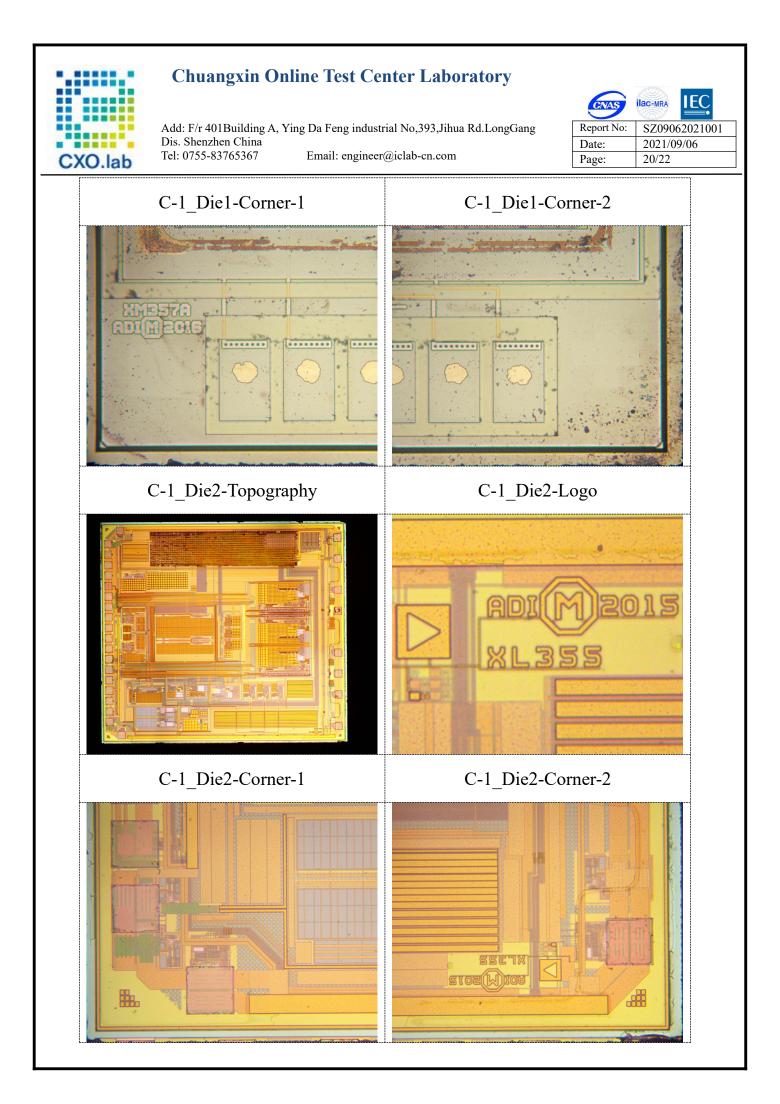
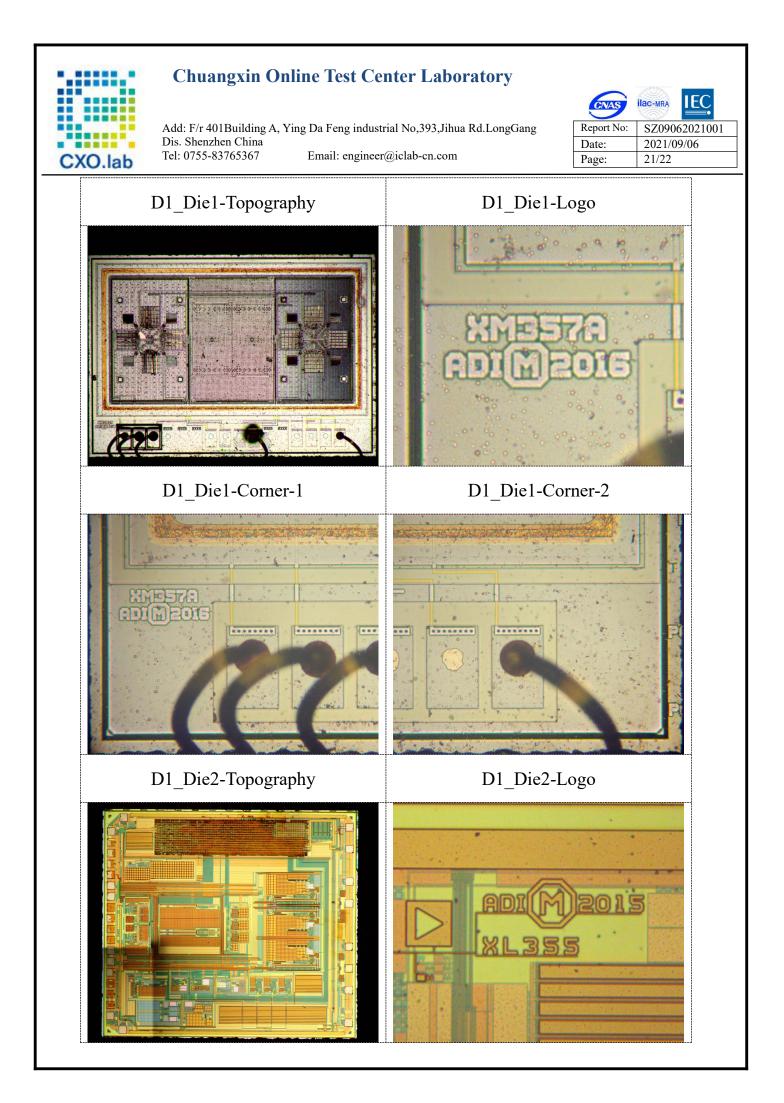
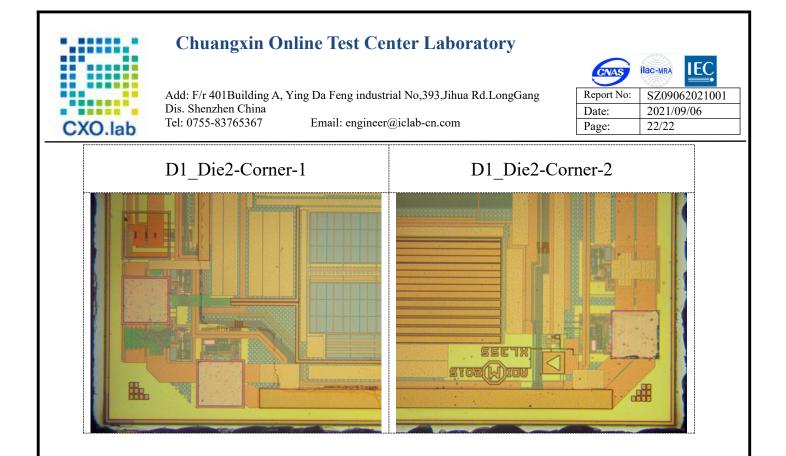
# 8.Internal Visual Inspection:

Internal Visual Inspection was verified on 3PCS (B1, C-1, D1) samples. 2 dies (Die1&Die2) were found.

Die1: Manufacturer ADI marking were found with 2016 copyright year. Die marking XM357A were found on the die surface.

Die2: Manufacturer ADI marking were found with 2015 copyright year. Die marking XL355 were found on the die surface.

Summary: All samples show the same structures and marking and samples confirmed to be a ADI device.
