Report No:	SZ20240223002
Date:	2024/02/23
Page:	1/15

Failure Analysis Report

Description	Integrated Circuit
Part No	AP3211KTR-G1
Date Code	N/A
Date of Received	2024. 02. 20
Customer Company

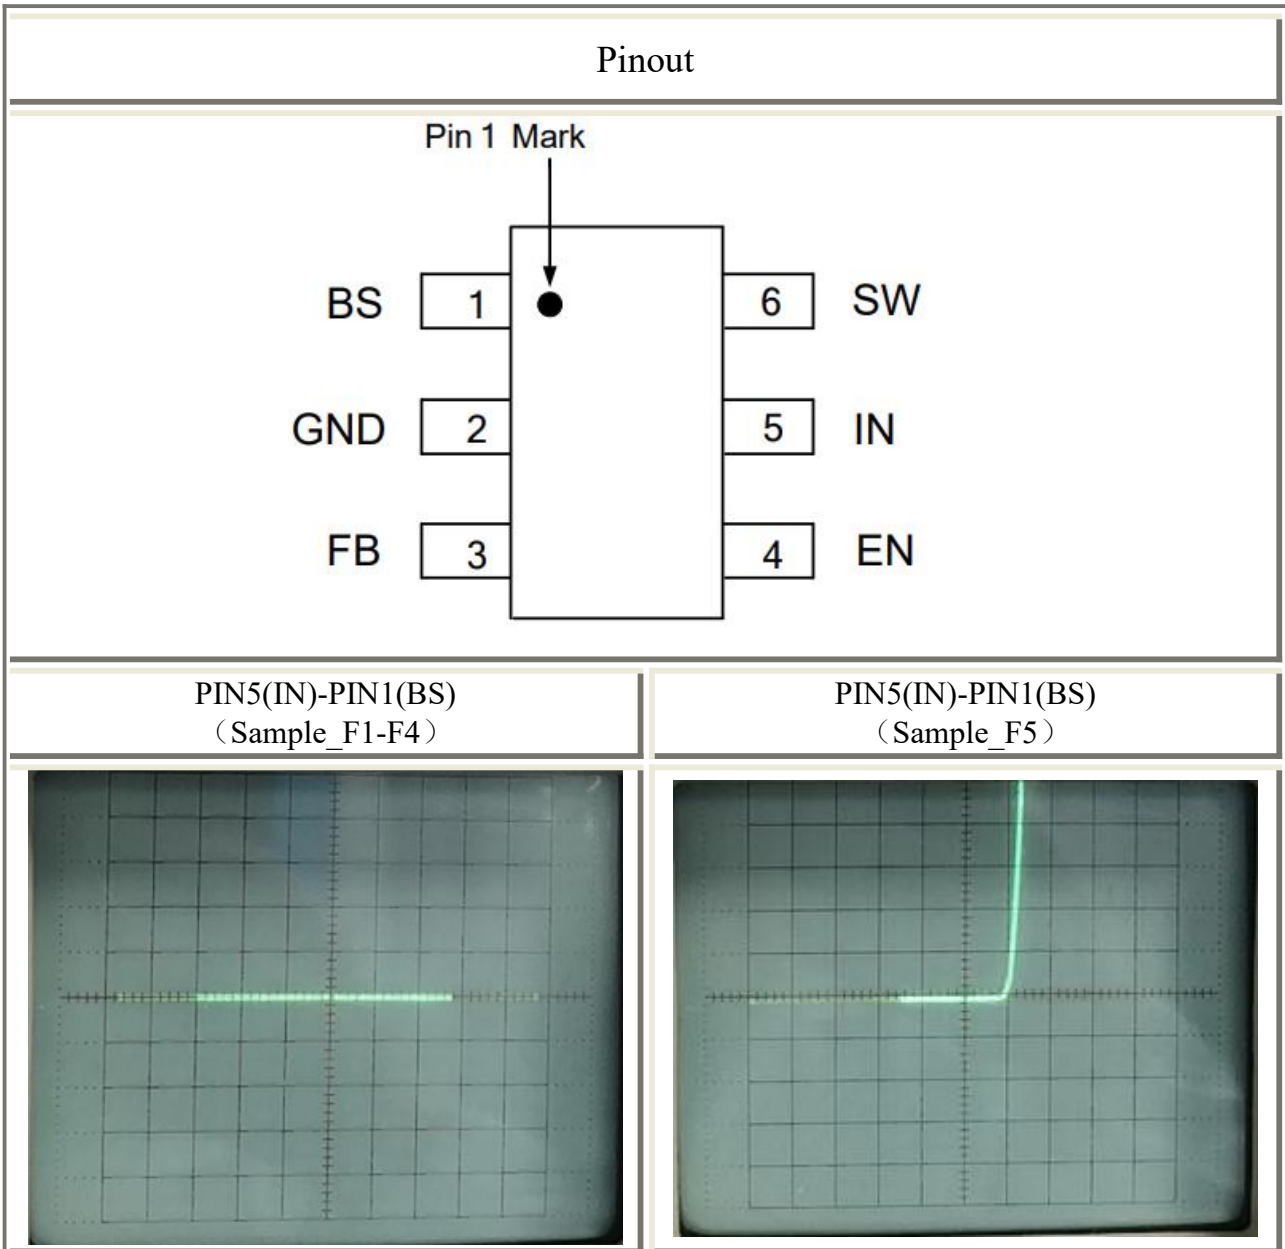
Electrical characteristics analysis 5 PCS samples(F1-F5),No obvious abnormality was found in the failed product F1-F4.Electric leakage between PIN6(SW)-PIN2(GND) of invalid sample F5, short circuit between PIN5(IN)-PIN6(SW).
