Project Inspection Report

:	<u>N/A</u>
:	<u>N/A</u>
:	KM 33uf50 5-11
:	2 <u>pcs</u>
:	2 <u>pcs</u>
:	04/03/2018
:	04/03/2018
	: : : :

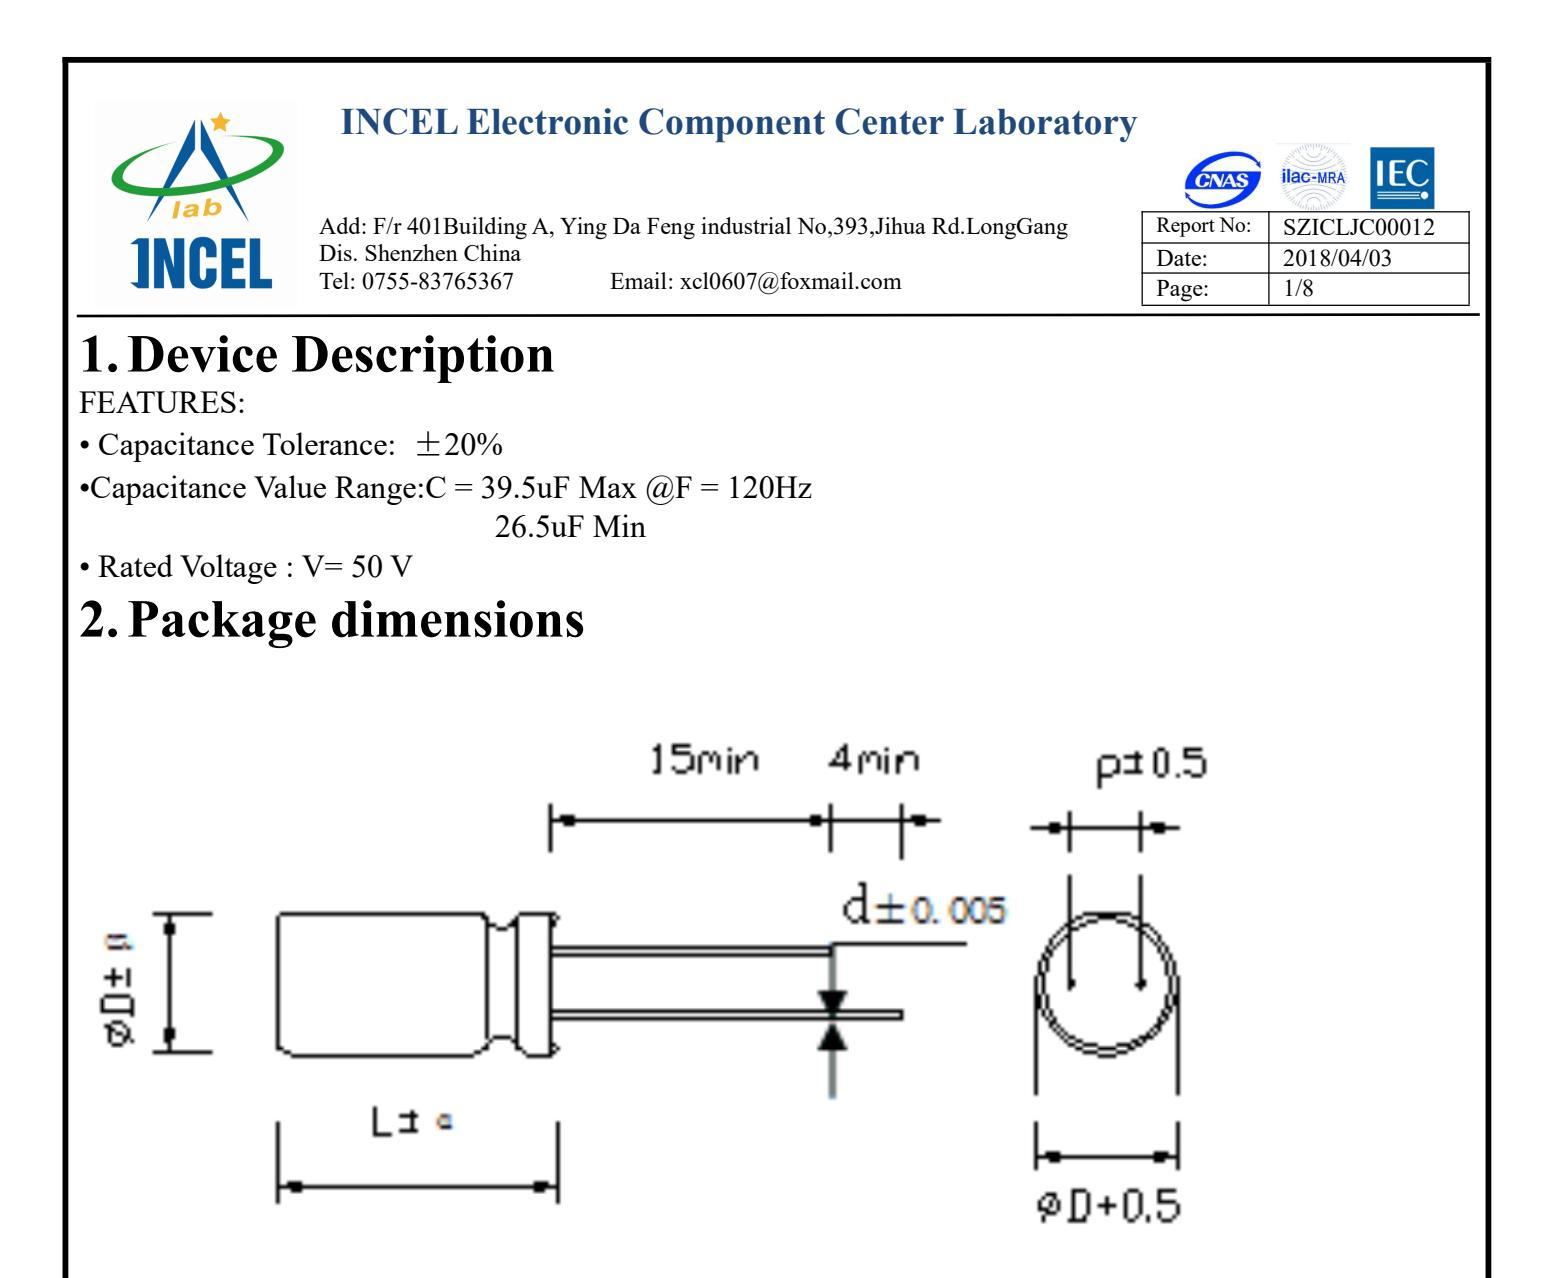
Note: The measured Capacitance value is below the minimum Capacitance. By analyzing the following conclusions: Electrolyte of leakage make the capacitance decreases.

Internal Visual Inspection device was verified on (1) sample. No abnormal was found on the AL surface. Dried up electrolyte paper was found at the device surface.

Electrical Level 1 Test Result			
Tested Parameters	Result		
Rate Voltages	pass		
Capacitance Tolerance	fail

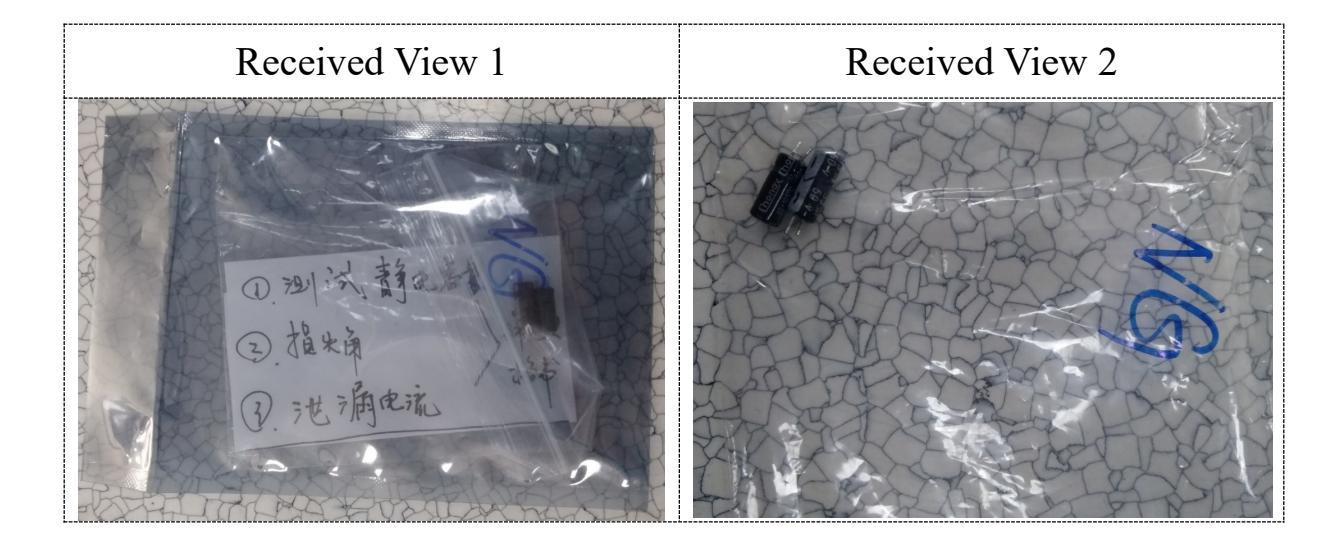
3. Receiving Inspection

Cross Weight:	0.5KG	Parts Total	2PCS
Number Of Boxes	N/A	Box Condition	Non Present
Package type	N/A	Moisture protection	Non Present
MSL	N/A	ESD protection	Non Present

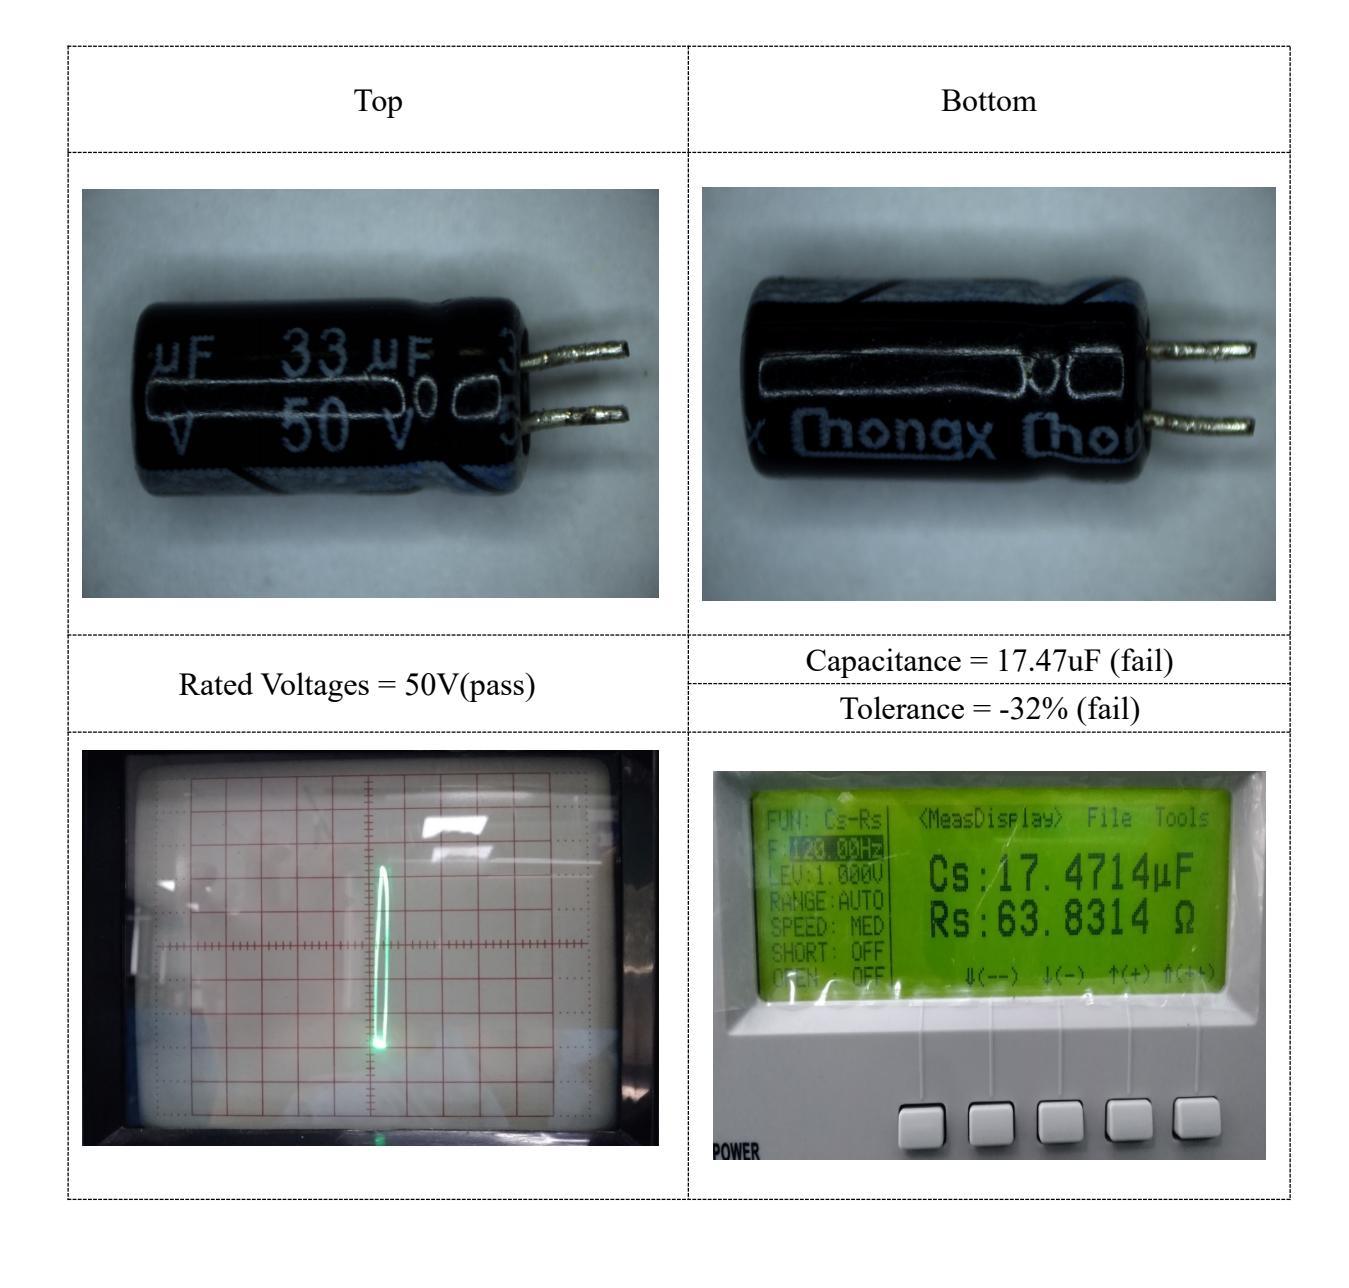
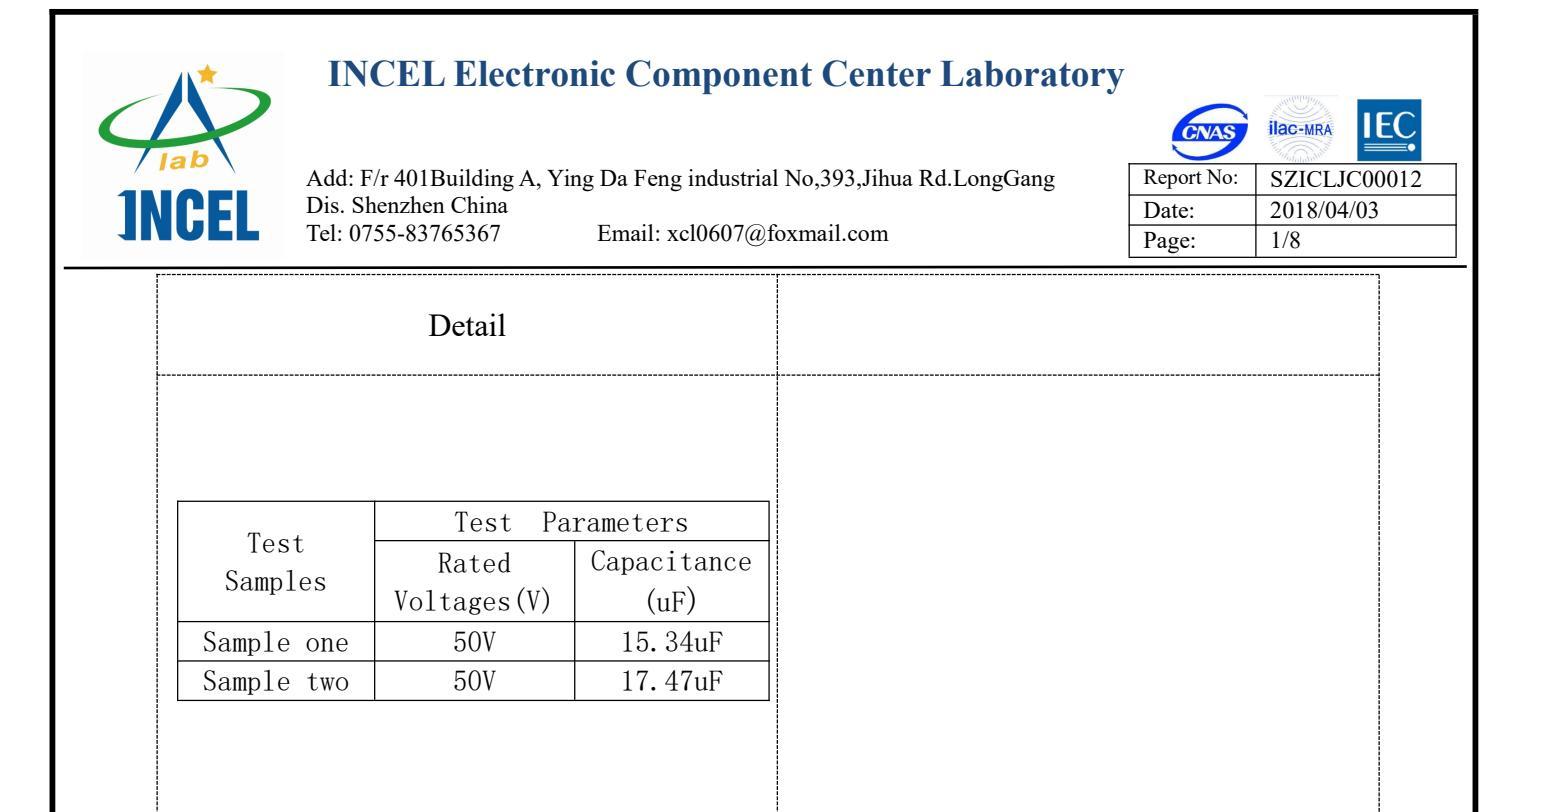
4. Electrical Level 1 Test

- Rated Voltage: V = 50V
- Capacitance Tolerance: $\pm 20\%$
- Capacitance Value Range: C = 39.5uF Max @f = 120Hz

26.5uF Min

Total quantity tested: 2pcs.

Total quantity passed: 0pcs.

Total quantity failed: 2pcs.

Note: The measured Capacitance value is below the minimum Capacitance. The breakdown of the equipment may be caused by the oxygen ion supplied by the working electrolyte under the action of an applied electric field, which can form a new oxide film at the damaged site and make the anodic oxide film filled and repaired. It may even become a through hole to break the device.

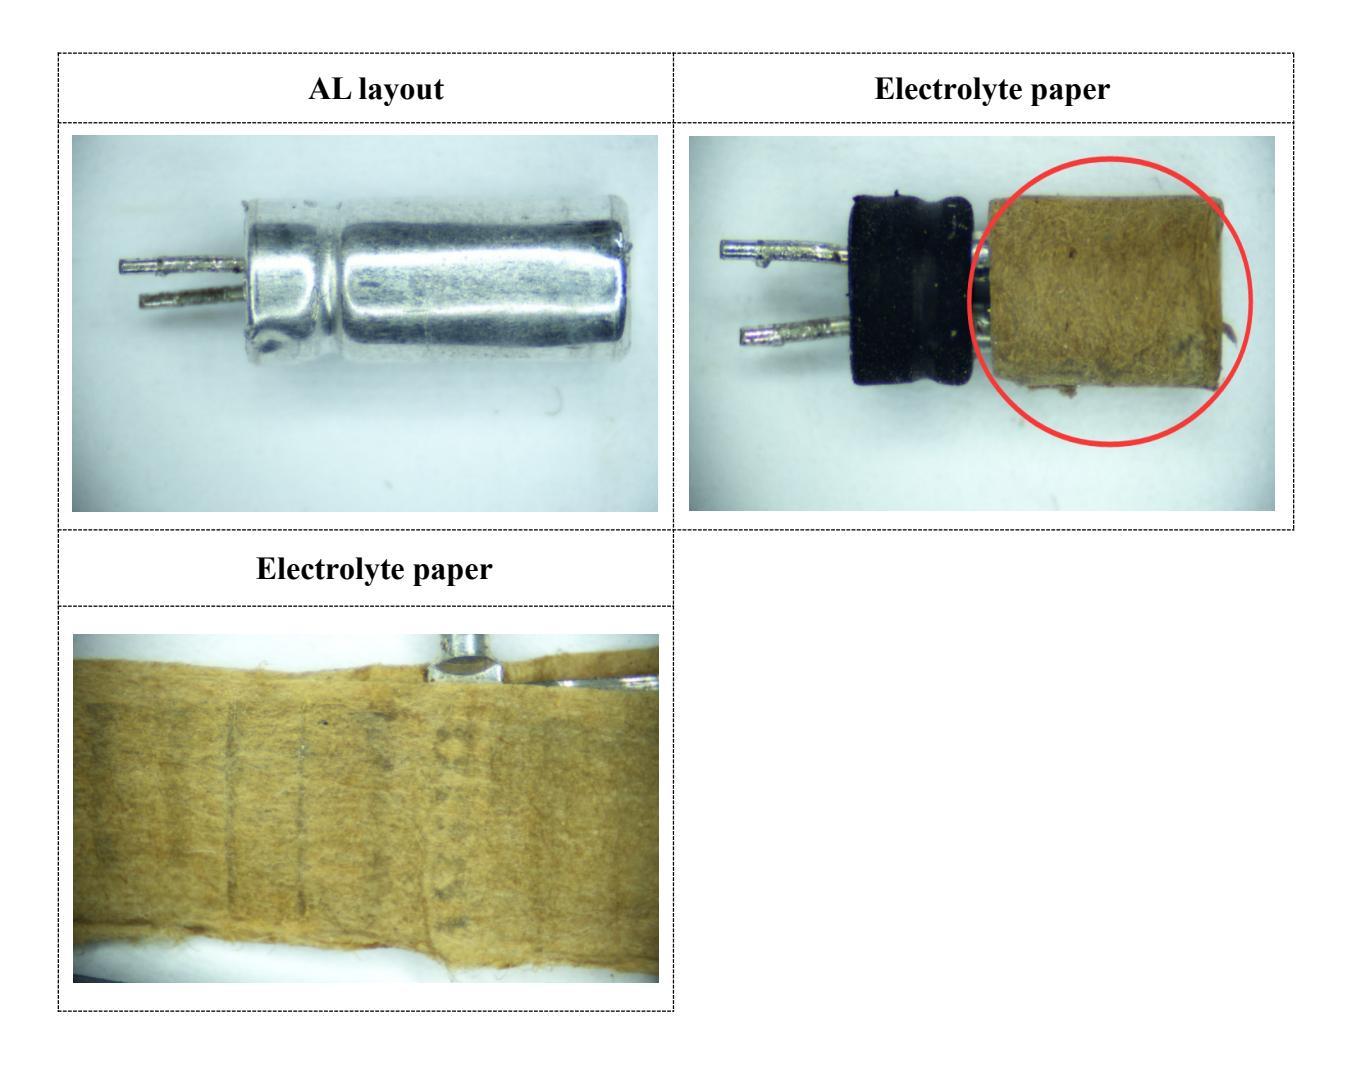
5. Internal Visual Inspection

Internal Visual Inspection device was verified on (1) sample. No abnormal was found on the AL surface. Dried up electrolyte paper was found at the device surface.

From the above analysis results, Leakage reason comes from increase in temperature, overvoltage, a vibration, or a defective seal may accelerate deterioration of the sealing performance. Leakage results in a decrease in capacitance, an increase in equivalent series resistance, and a corresponding increase to power dissipation. Leakage reduces the working electrolyte and loses the ability to repair the anodized film media, thereby losing the self-healing effect. When the electrolytic capacitor is left for a long time, the leakage current tends to increase due to the action of the primary battery. Therefore, before using an electrolytic capacitor that has been placed for a long time, it is necessary to apply a rated voltage until its electrical characteristics return to normal. In addition, pay attention to the MSL condition and according to the datasheet specification application.
