中国认可
国际互认
检测
TESTING
CNAS L12524

Test Report

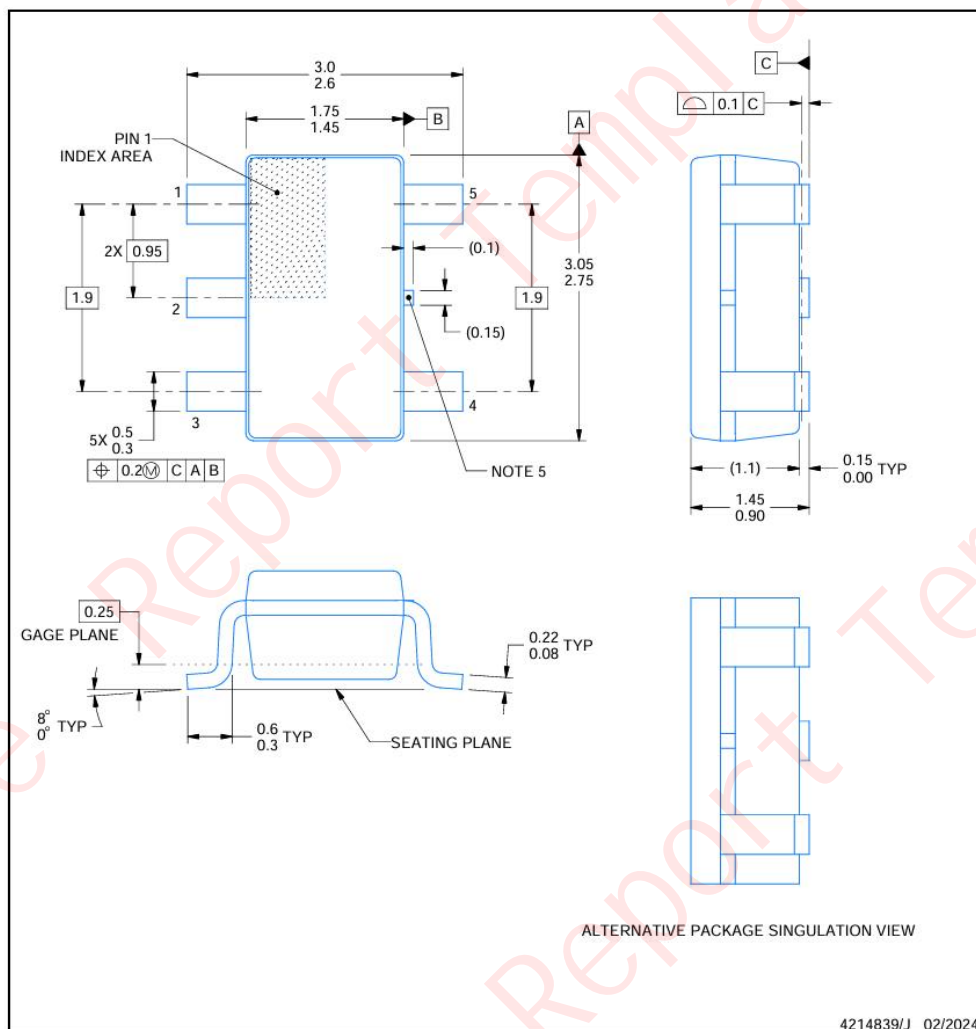
3. Documentation and Packaging inspection:

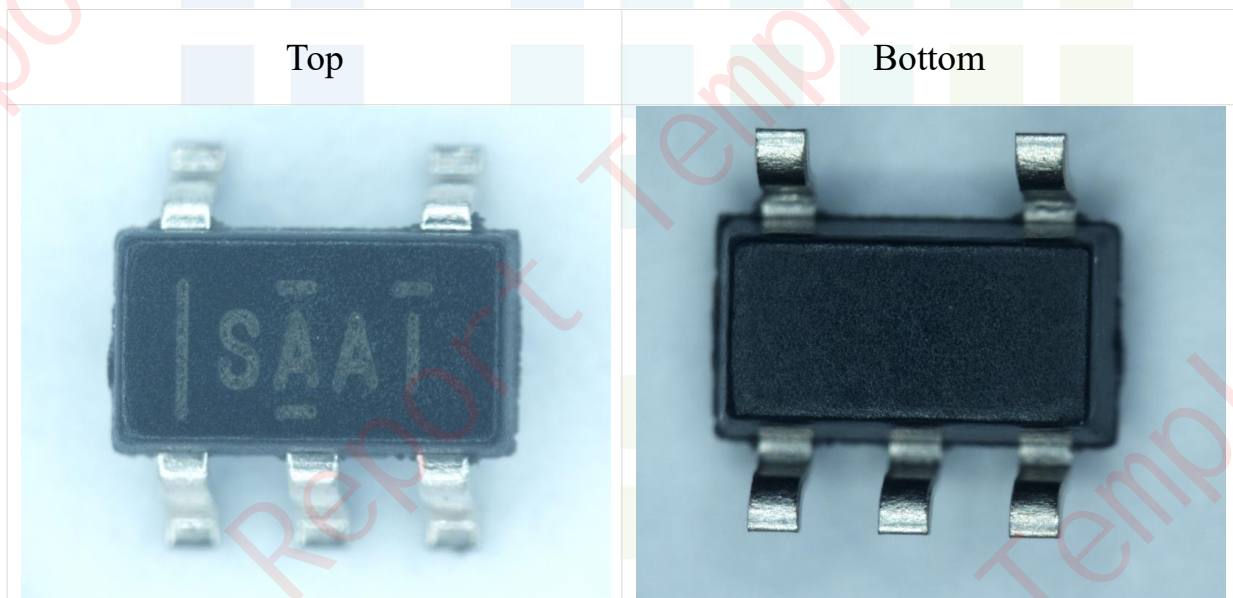
Devices confirmed to be the TI device.
