Report No:	SZ12162020006
Date:	2020/12/16
Page:	1/18

Project Inspection Report

Company : N/A
Address : N/A
Sample Name : S912ZVMC12F3MKH
Manufacture : FREESCALE
Date Code : 1748
Sample Number : 5 PCS
Check Number : 5 PCS
Date of Received : 12/14/2020
Date of Tested : 13:00/12/14/2020~14:50/12/14/2020

4. Solderability Analysis:

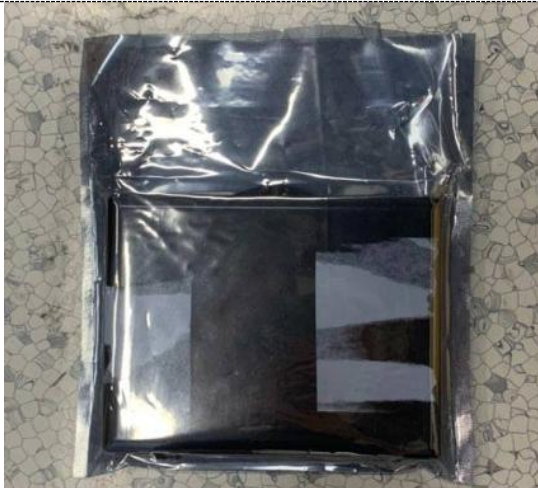
Received View-1

Gross Weight:	59 g	Parts Total	5 PCS
Number Of Boxes	1	intact label	Non Present
Package type	Bulk	Moisture protection	Non Present
MSL	N/A	ESD protection	Acceptable

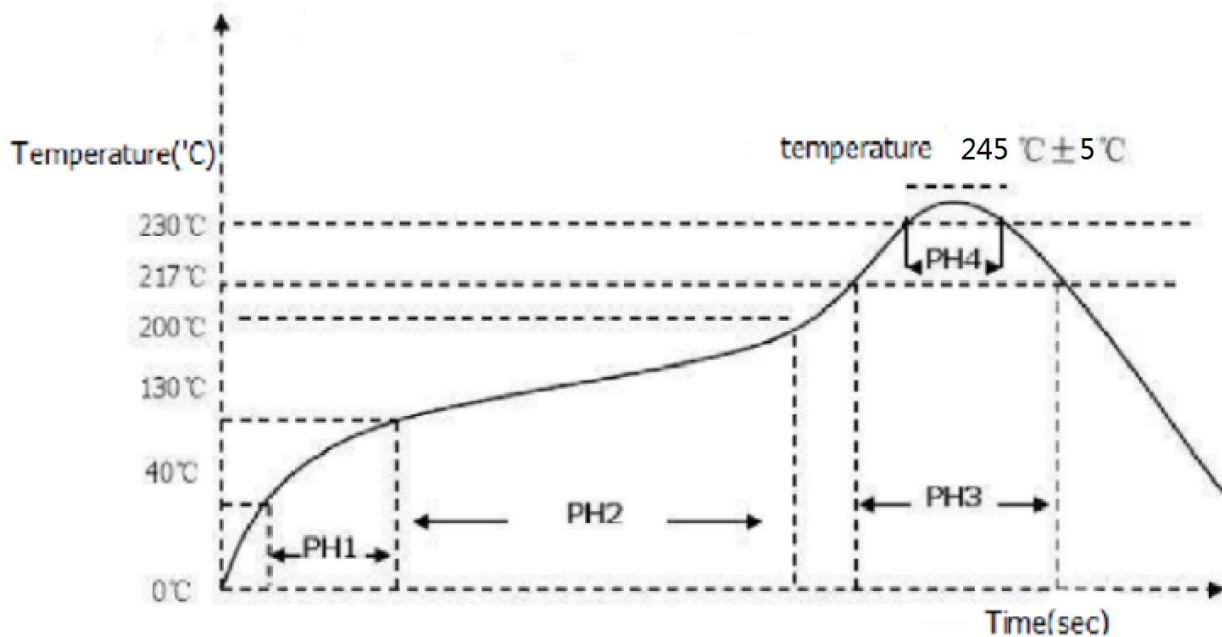
Furnace temperature curve analysis

Room Temperature	20.8°C	Relative Humidity	47%
Immersion speed and lifting speed	0.984 in	Flux Immersion Angle	45°
Solder Pot Temperature	245°C	Solder material	Sn96.5Ag3.0Cu0.5
Solder Method	Dip and Look Test	Solder Immersion Time	5S

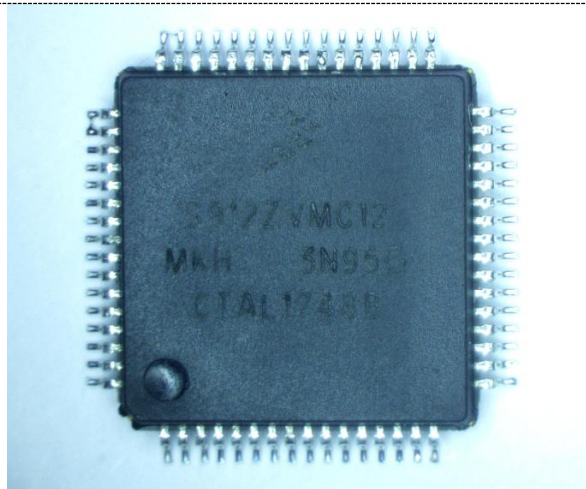
#1-After Top View

Solderability test was performed on 5 PCS samples marked with samples (#1-#5) using the dip and look methods. All devices failed solderability test. The dipped portion of the terminations is less than 95% covered by a continuous new solder coating.
