Chuangxin Online Test Center Laboratory

Add: F/r 401 Building A, Ying Da Feng industrial No,393,Jihua Rd.LongGang
Dis. Shenzhen China
Tel: 0755-83762185 Email: engineer@iclab-cn.com

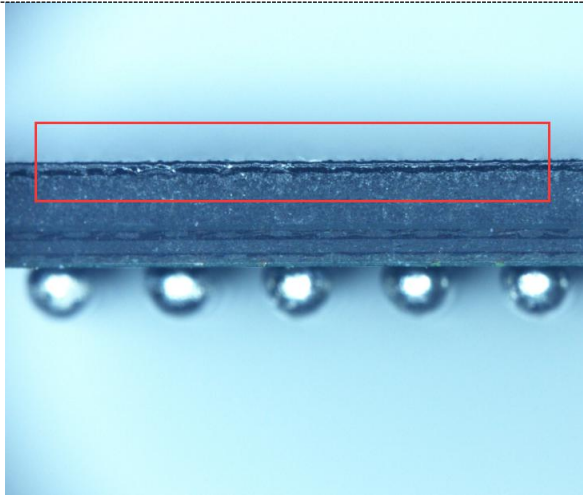
Top Permanency Tested (Failed)

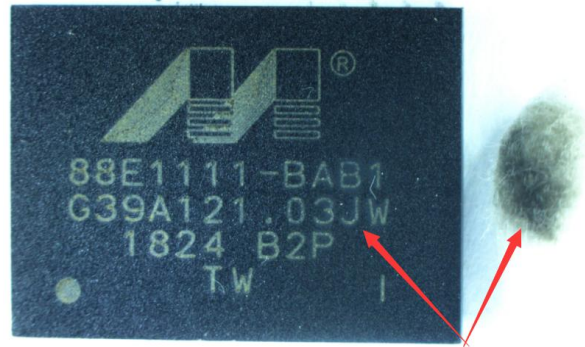
Substrate Residues-1
