Report No:	SZ20240223002
Date:	2024/02/23
Page:	1/15

Failure Analysis Report

Description	Integrated Circuit
Part No	AP3211KTR-G1
Date Code	N/A
Date of Received	2024. 02. 20
Customer Company

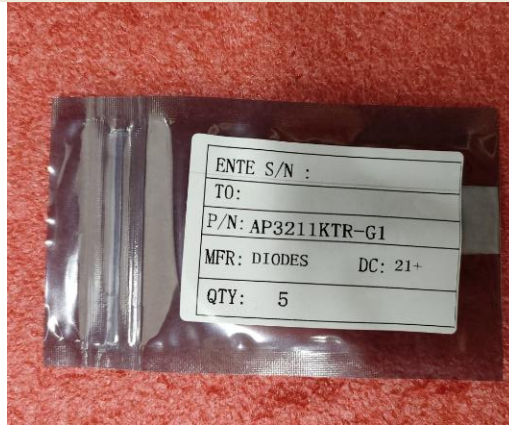
Incoming picture-1

External Visual Inspection on 5PCS samples(F1-F5), No obvious abnormality was found.

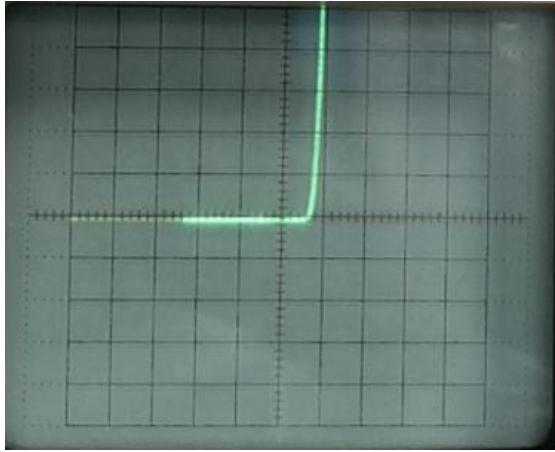
PIN5(IN)-PIN2(GND)
(Sample_F1-F4)

Electrical characteristics analysis 5 PCS samples(F1-F5),No obvious abnormality was found in the failed product F1-F4.Electric leakage between PIN6(SW)-PIN2(GND) of invalid sample F5, short circuit between PIN5(IN)-PIN6(SW).

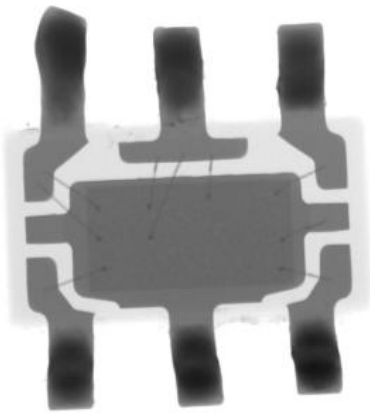
F1-Top View-All

X-ray Inspection on 5 PCS samples(F1-F5).No structure or bonding wire abnormal was found.

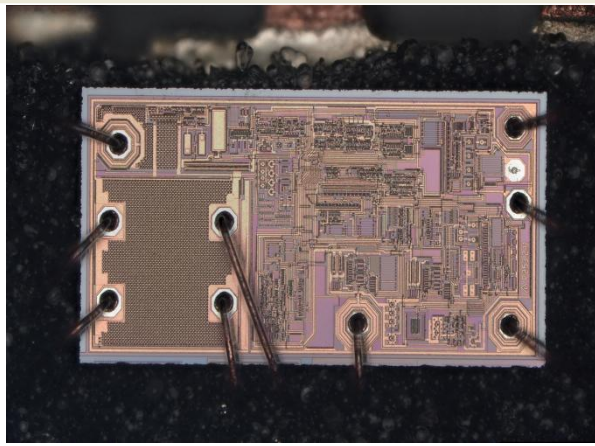
F1-Die Topography

Internal Visual Inspection was verified on 2PCS (F1,F5) samples. No abnormality was found on the Die surface of F1.EOS damage was found on Die surface of invalid F5.

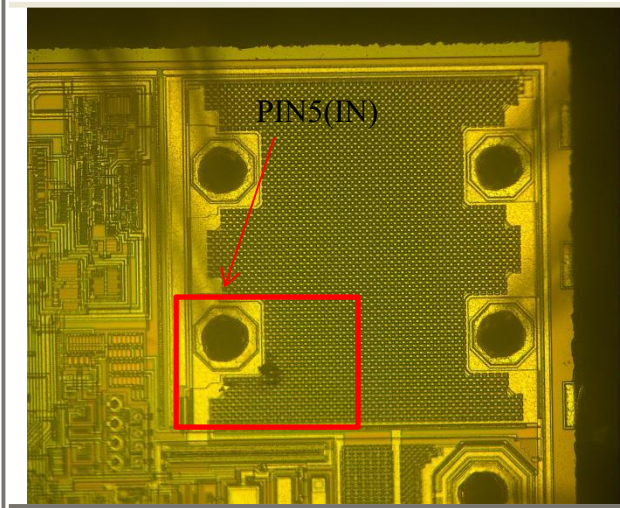
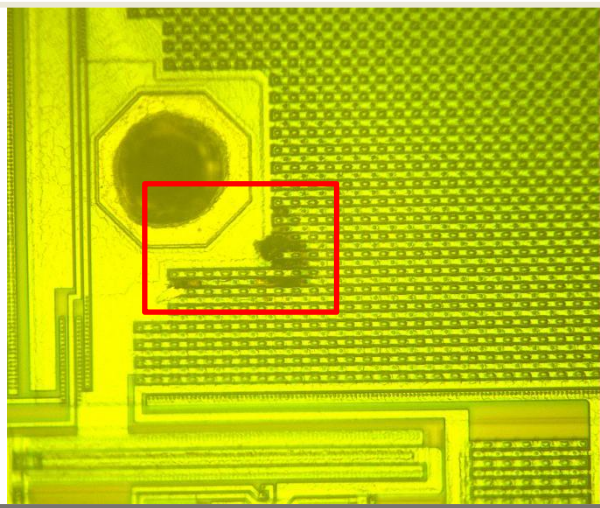
F5-EOS-2

To sum up, the test analysis shows that the failure of F5 is caused by EOS damage caused by overelectric stress.No obvious abnormality was found in the failed product F1-F4.

1. It is recommended to provide a comparative analysis of good products to further confirm the failure point.
2. Optimize the protection circuit and take anti-static measures.
